Sanitary Zoo Enclosure Lining

Featuring Polyshield HT™

Project:
Elephant Enclosure Area of Zoo

Location:
Portland, Oregon

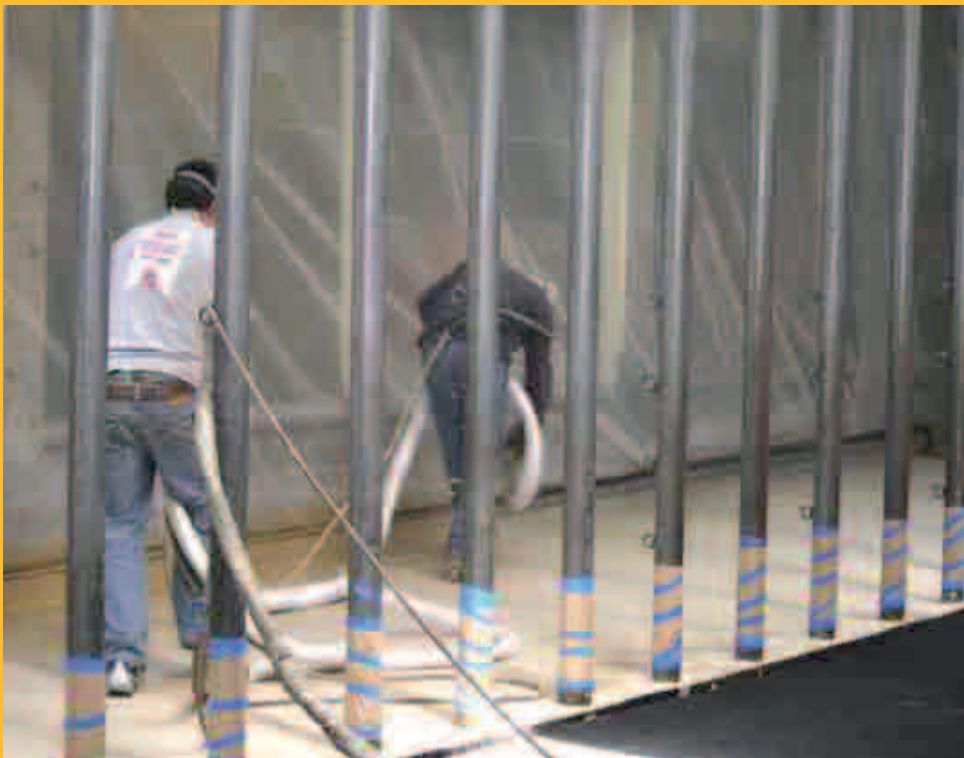
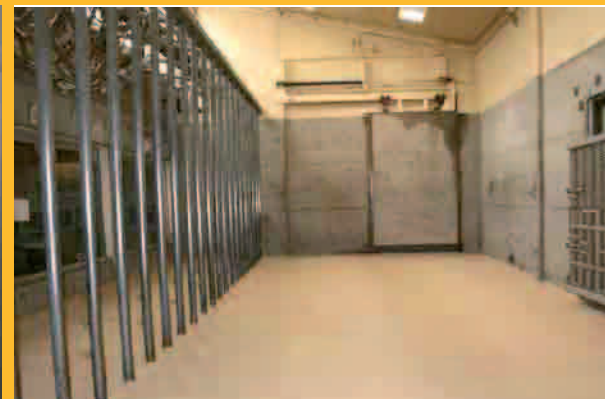
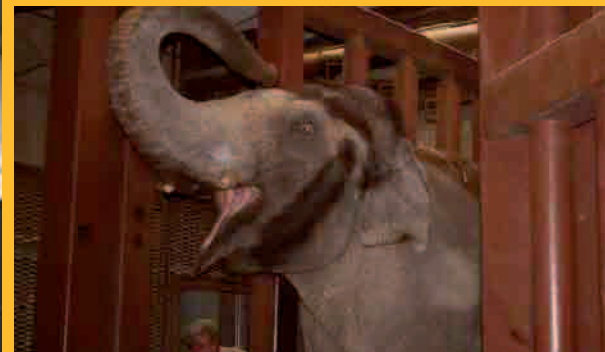
In the elephant viewing area, rubber mats over the concrete floor are provided for the elephants to stand on. The mats were coated with urethane to waterproof and protect against wear and tear. This coating became ragged and started to crack. Curious elephants started to pull on the loose pieces of coating. The damaged mats remained wet, and quickly became unsanitary for the elephants and zoo patrons. The zoo needed a new sterile coating to protect the rubber mats from bacteria and waste. It was critical for the coating to withstand high point loading stresses associated with the elephants walking on it.

The old mats were removed and replaced with a ¾-inch thick rubber mat and over-laid with Polyshield HT™ at a thickness of 120-150 mils.

Polyshield HT™ provided a high-strength, resilient coating that can endure the elephant's weight. It also created a seamless protective membrane that resists bacteria and allows for the elephant waste to be easily cleaned several times a day with high pressure water hoses.
