# Sanitary, Cleanable Coating

## Featuring Polyshield SS-100®

Milk Parlor Floors

100 mils POLYSHIELD SS-100®

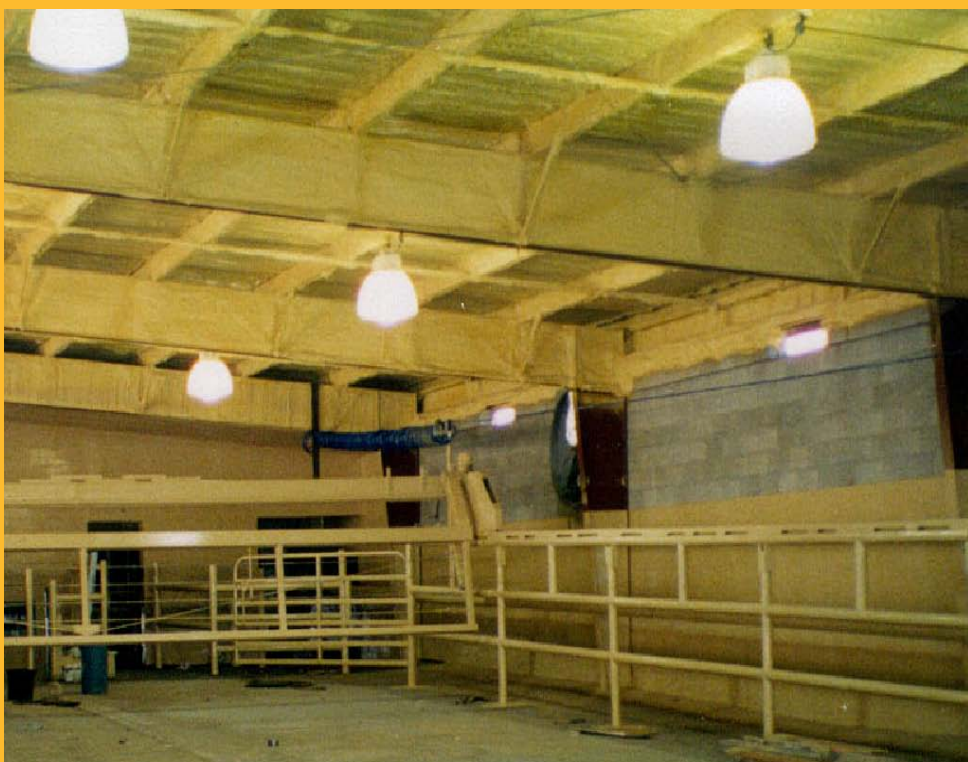
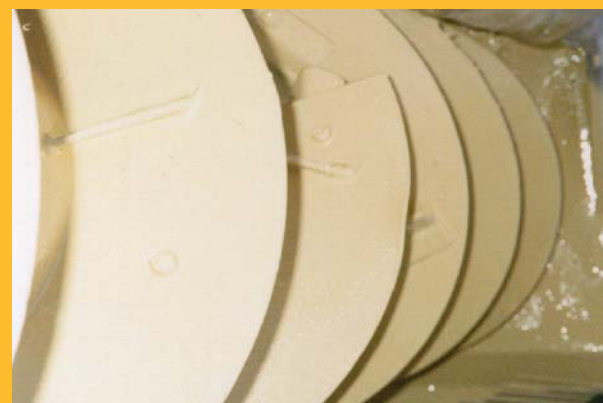
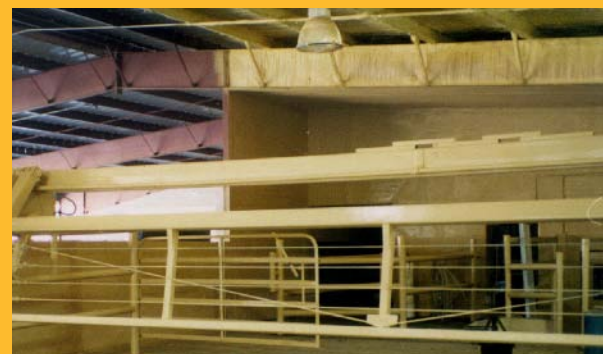
The dairy farm's milking parlor uses both galvanized and stainless steel in the facility. The steel was unprotected and difficult to clean. The project consisted of 40,000 sq. ft. of floors, walls, ceilings, crowd gates, posts, and rails that needed to be coated for easy wash down.

June 1999: The product was performing well. There were no visible signs of lost adhesion, pinholes, or cracks. Some discoloration has occurred due to the dairy's sterilization chemicals.

Polyshield SS-100® polyurea was specifically chosen for its easy cleaning and sanitation properties. The floor areas were cleaned, primed with SPI Primer, and coated with 100 mils of Polyshield SS-100®. Then, an aggregate was broadcast into the basecoat, followed by a 30-mil topcoat to lock it in. This step was necessary in order to create a non-skid coating surface.
