# Methane Gas Protective Liner

## Featuring Polyshield SS-100®

Landfill Leachate  
Collection Boxes

Morrisville, PA

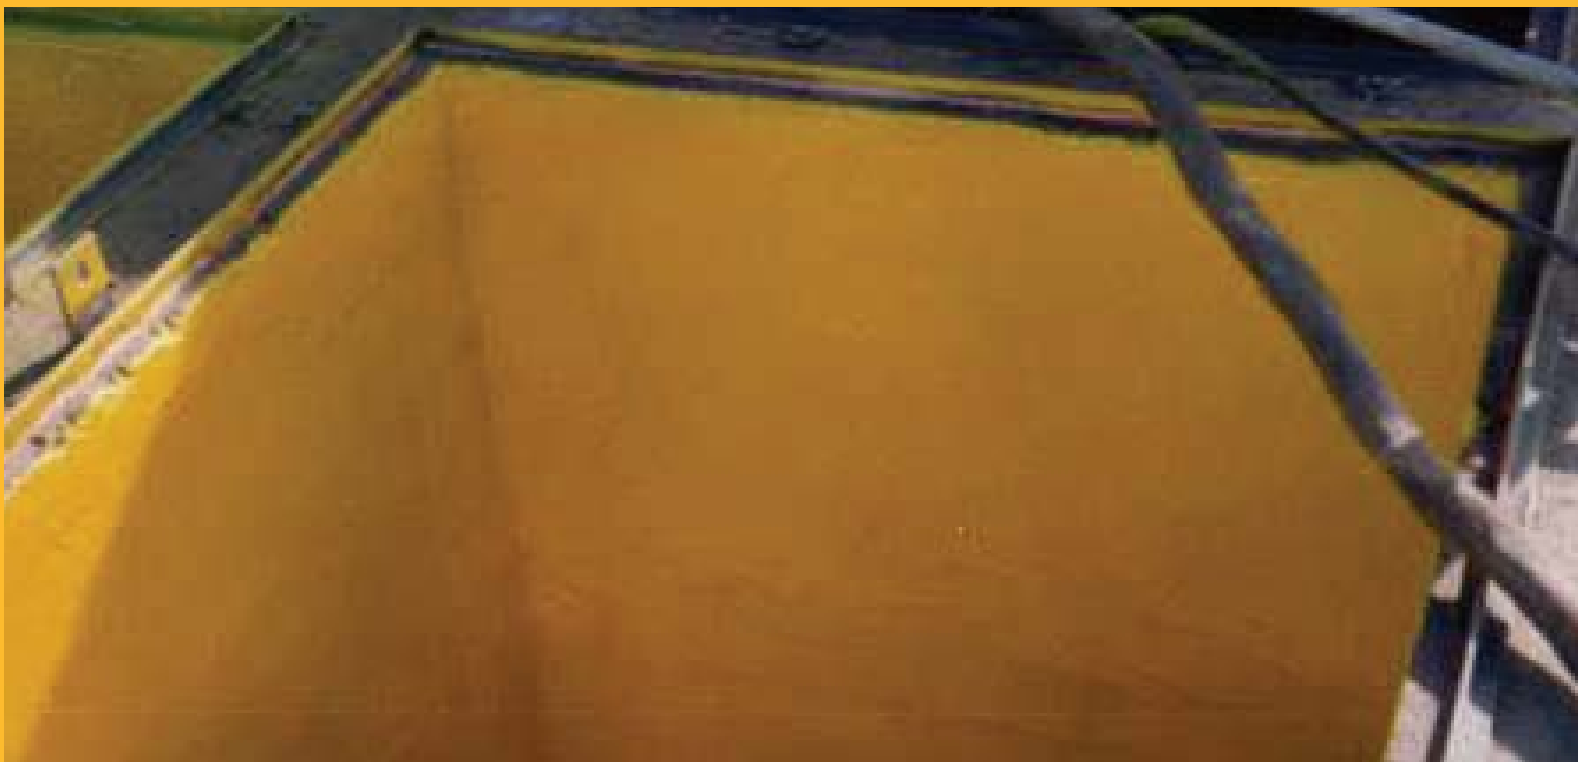
The concrete leachate collection boxes at the Grows Landfill were deteriorating. The damage was being caused by bacteria growth feeding on the methane gas created by the landfill waste. The bacteria secretes acidic enzymes that breakdown silica & calcium in the concrete.

Grows Landfill Waste Management needed an interior lining to protect the leachate collection boxes from further damage. In order to prime the surface, the concrete was heated, which pushed the water vapor back, allowing the concrete primer to be properly

applied and cured. Polyshield SS-100® was then applied over the prepared concrete at 250 mils.

The Polyshield SS-100® polyurea coating created a seamless barrier that sealed off the concrete, protecting it from further bacteria damage.
