Leak Prevention

Featuring Polyshield SS-100®

Project:
Deionized Water Tanks

Location:
Magna, Utah

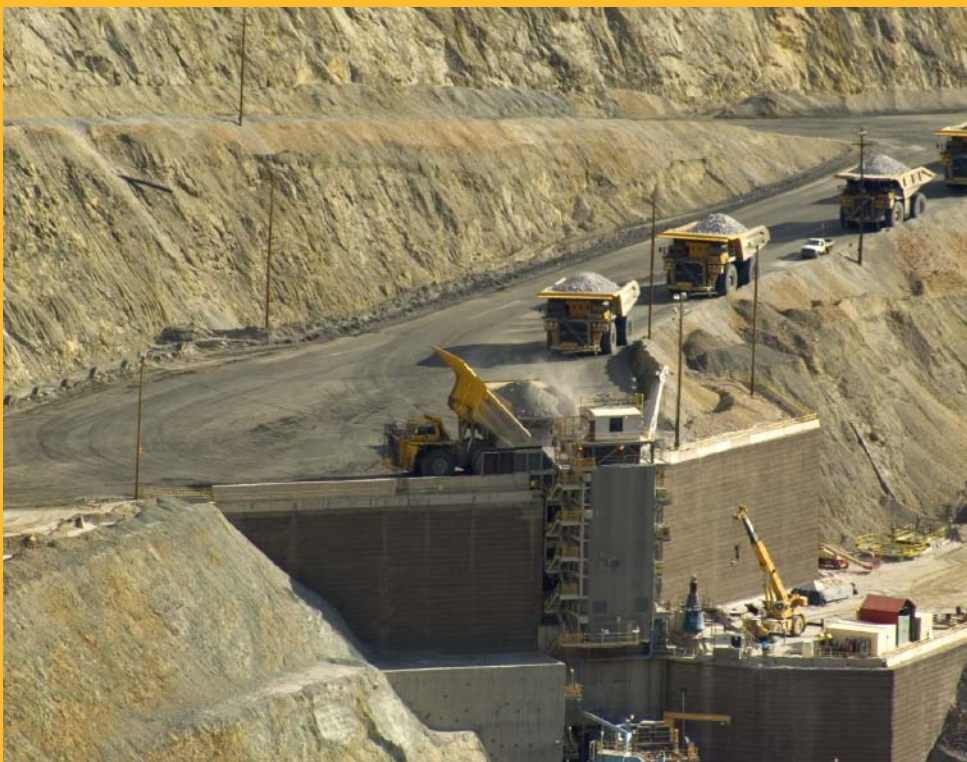
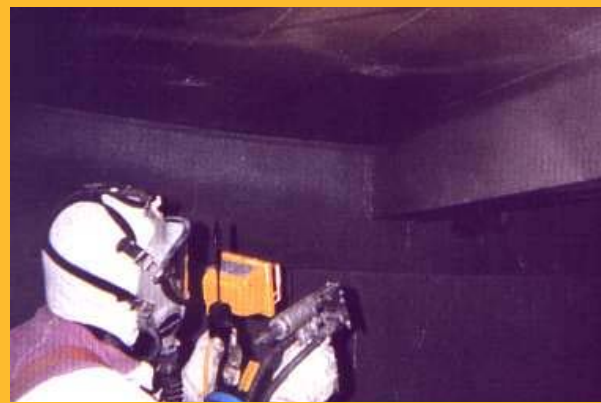
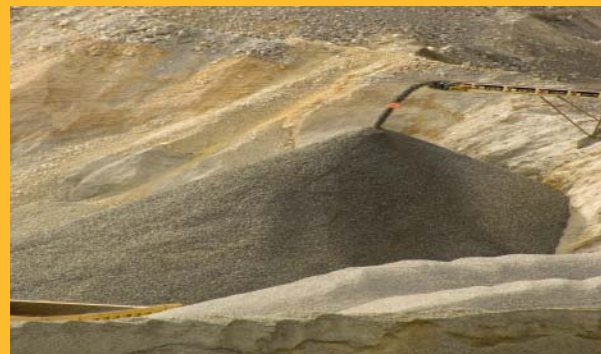
Mine personnel discovered leaks in two concrete storage tanks. The tanks were originally used to store lime solution and were being converted for deionized boiler water storage. When the tanks were first converted the mine owner lined the floors and walls with an epoxy coating. Subsequently, when the tank was filled with water, leaks were observed. The epoxy had failed and they needed a superior solution.

contacted Hydrodynamics to find a coating solution. Hydrodynamics recommended SPI's Polyshield SS-100® polyurea due to the product's water resistant and elastomeric properties. The inside of epoxy-coated concrete storage tanks were grit-blasted, followed by epoxy grouting in areas that were cracked. Then Polyshield SS-100® polyurea was applied at 60-80 mils (1½-2mm) on the tank floors and walls.

In October 1996, the owner was contacted regarding performance of the tanks. SPI was informed that the Polyshield SS-100® polyurea coating was performing well and there were no visible signs of damage.
