## Water Conservation

# Featuring Polyshield SS-100®

Restoration of  
Metal Irrigation Flumes

Columbia Irrigation District

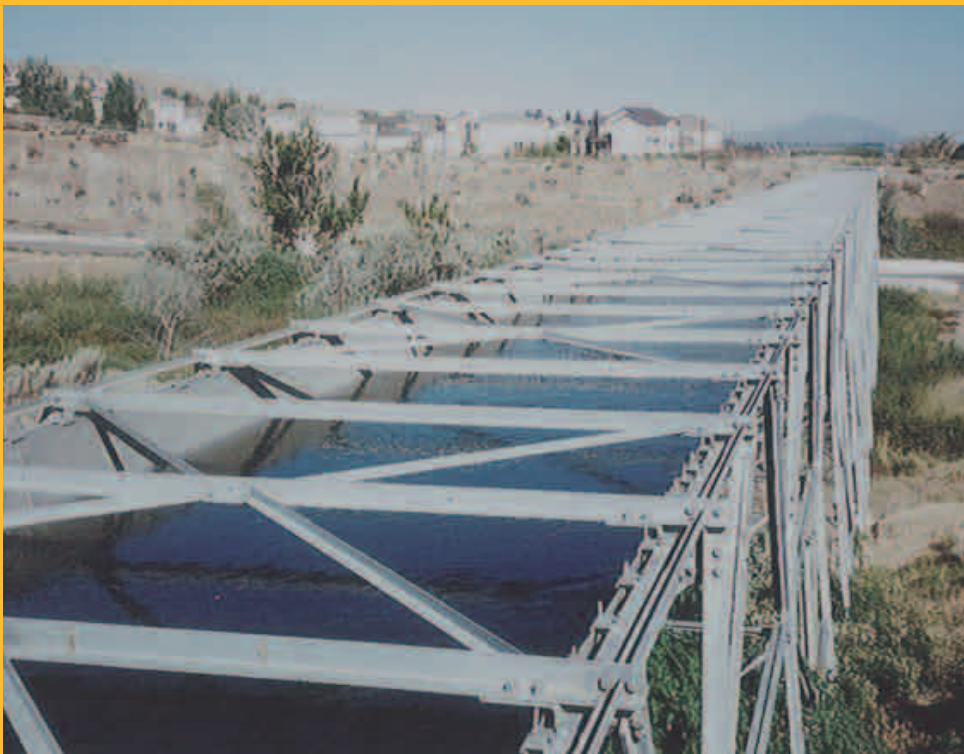
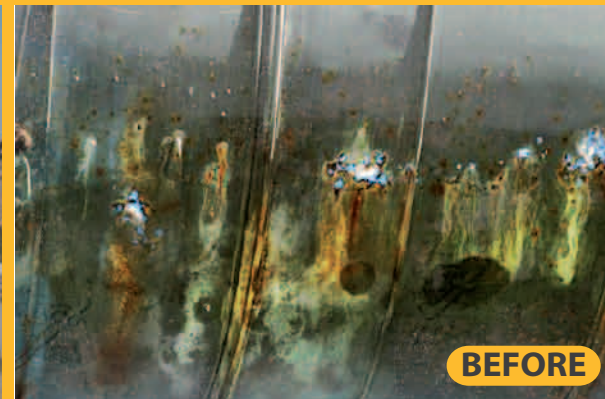
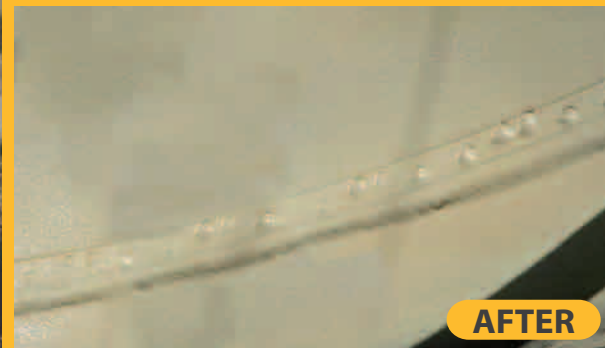
Three galvanized steel flumes originally constructed in 1984 were corroded and leaking. The replacement of the flumes and other repair methods were evaluated, but not feasible due to cost. The irrigation district chose Polyshield SS-100® for its corrosion resistance, its ability to bond to steel, and it was determined to be the most economical solution.

Preparation of the flumes consisted of grit-blasting a 3 to 4 mil anchor profile. One flume was so badly corroded that blasting created holes in the steel.

Polyshield SS-100® was used to coat the outside of the flume.

This section then acted as a mold-form for the interior to be blasted and sprayed. The result was a new flume section consisting of SPI Polyshield SS-100® applied at 50 mils to the exterior and 100 mils on the interior of this section.
