Monitor Window Encapsulation

Featuring Glass Shield-100™

Glass Windows
Pontiac East Truck Plant

Detroit, MI

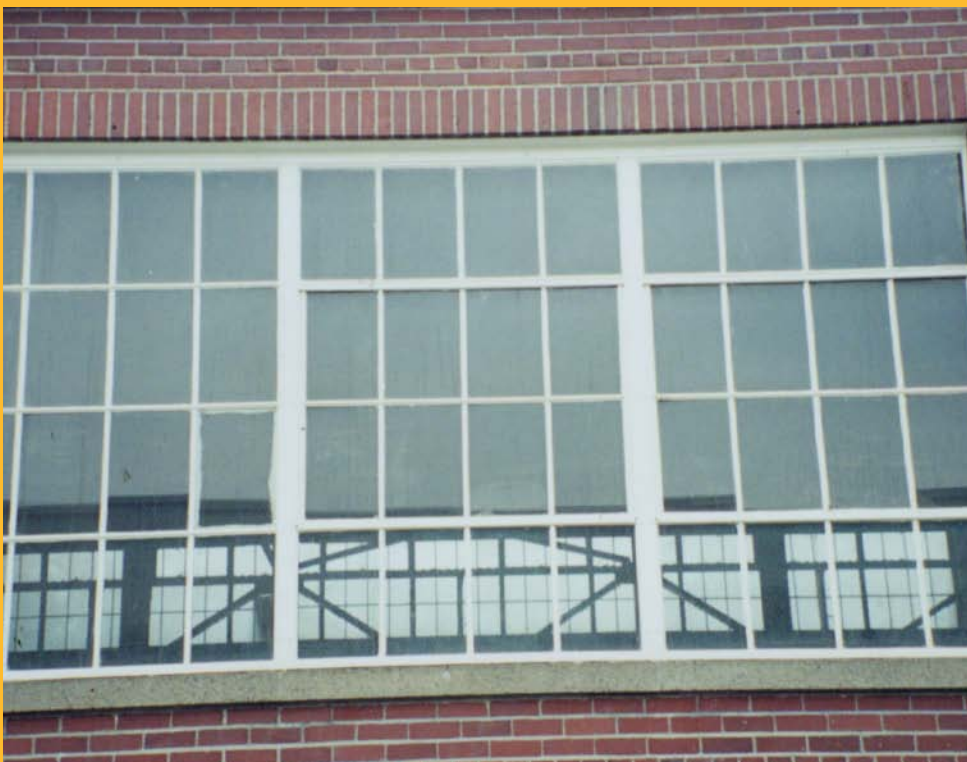
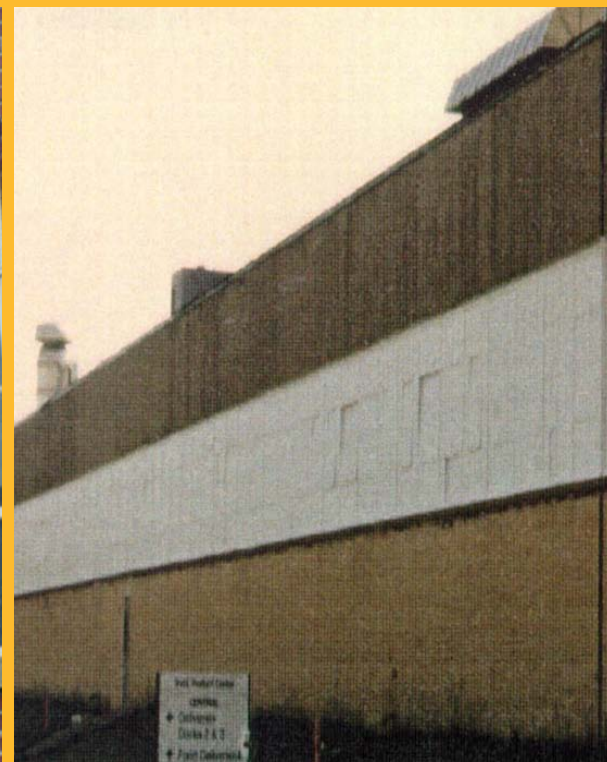
The monitor glass windows in GM's Pontiac truck plant's were aging and beginning to leak. Several of the deteriorated windows started falling out and crashing down onto the plant floors. These windows became a serious safety hazard. They needed to be stabilized and sealed, but due to the age of the windows, it had to be done without any type of surface preparation. The windows would have to remain in place and be encapsulated to prevent further damage, while eliminating any further risk of injury.

because of its durability and water resistant properties. The contractor applied Glass Shield-100™ polyurea at 24 mils on the inside and outside of the windows. Upon request from General Motors, SPI's A102 (single component polyurethane) was custom matched to their company colors and sprayed as a topcoat on the exterior.

The Glass Shield-100™ polyurea coating system stabilized and sealed the leaking, aging windows. Plant officials were satisfied with the solution, and relieved to have the safety issue resolved. The project owner awarded several new projects to the applicator in 2000 and 2002.
