Wooden Power Line Pole Fill

Featuring POLE FILL 10-4 & L-20 Internal Splint

Wood Pole Restoration

Hawaiian Islands

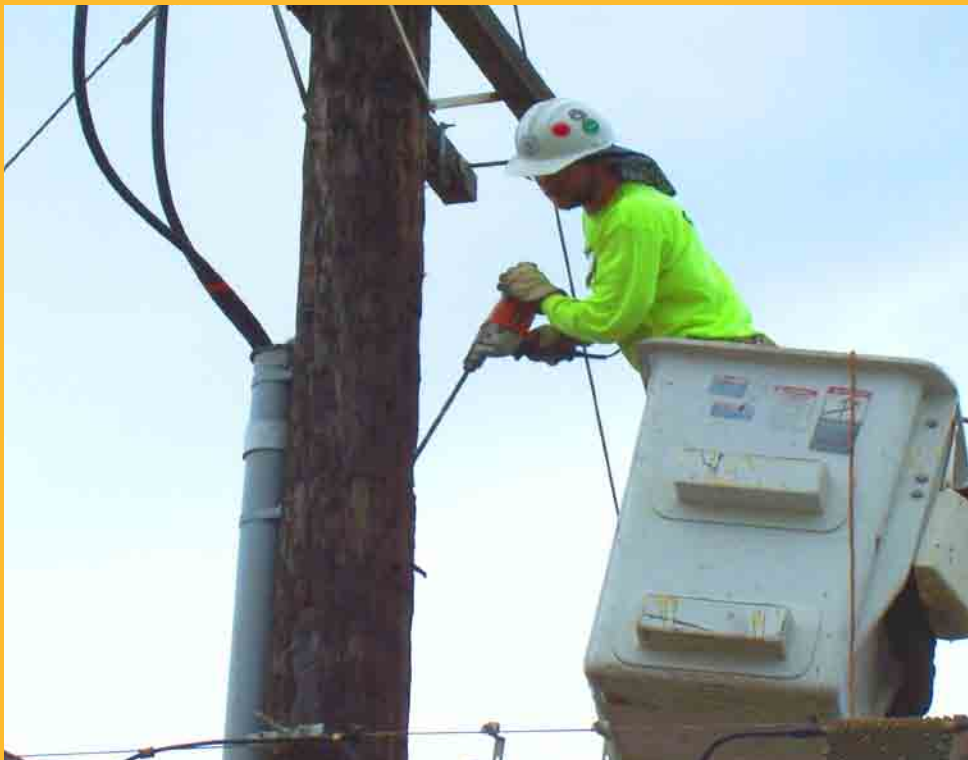
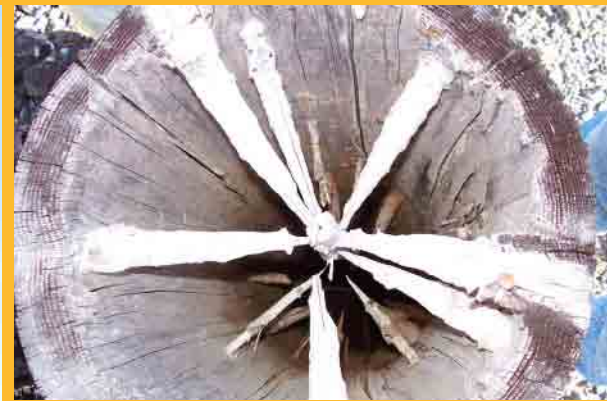
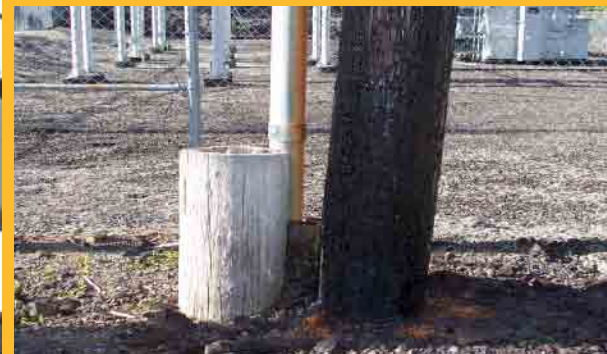
This project consists of the restoration of wooden power line poles, that are infested with termites. The termites are eating away some or most of the inside core of the wooden poles. In several instances, the damage is so severe there is less than 1 inch of the wooden shell remaining, weakening the pole and causing extensive repair costs.

SPI specifically formulated a urethane hybrid solution to inject inside the damaged power line poles. The custom formulated products Pole Fill 10-4 and L-20 Internal Splint are used to fill the cavities. The size of the pole, and how much of the inner core is missing, determines which of the specific formulations to use, and the number of gallons required for stabilization. Plugs are cut into each

pole so the application equipment can fit inside. The excess substances and insects are vacuumed out. Depending on how strong the client wants the pole, between 25 and 100 gallons of Pole Fill 10-4 and L-20 Internal Splint are pumped inside. The plugs are then pushed back into place to give it a good seal.

When hardened, the Pole Fill 10-4 and L-20 Internal Splint provides a strong, hard core inside the pole, that is impenetrable by termites and lasts for years. Over the past 15 years, the contractor's clients have been very satisfied with both products.
