Corrosion Control

Project:
HVAC Air Handling Systems

Location:
Thousand Oaks, CA

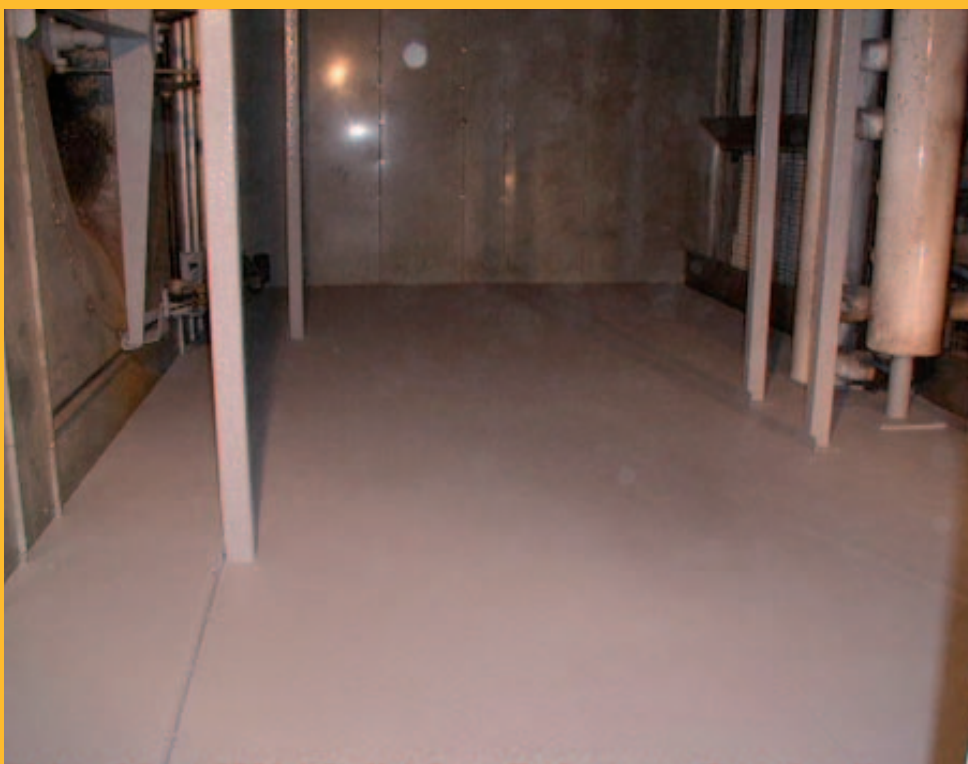
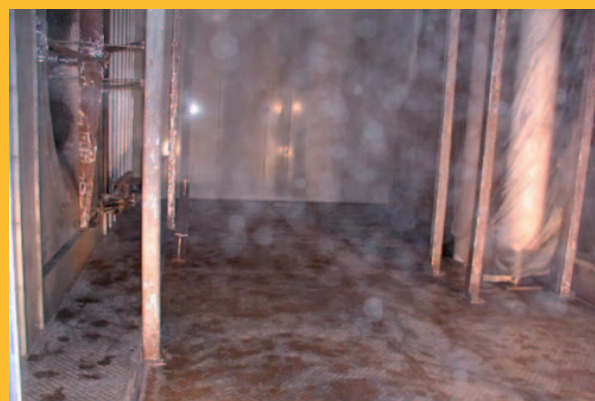
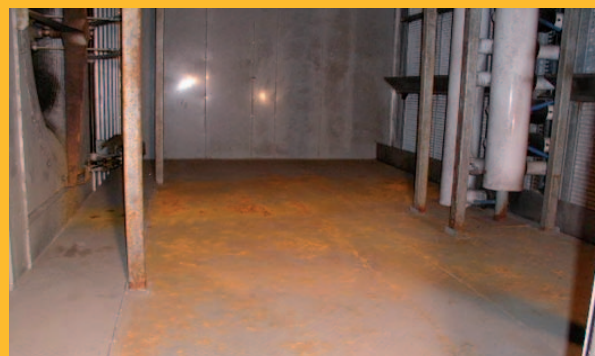
The HVAC air handling systems at a major pharmaceutical laboratory were severely corroded and began to leak. The air handling units had previously been coated with epoxies and needed recoating, due to numerous failures.

The project owner decided to use SPI's Polyshield HT™ polyurea because of the product's water resistance and high elongation properties. Before the polyurea coating could be applied, the failed epoxy coating had to be removed, along with a great deal of rust and corrosion. Grinders were used to remove the epoxy coating and corrosion, and to provide an anchor profile for proper adhesion to the

substrate. Polyshield HT™ with AE-4 (adhesion enhancer) was then spray applied at a thickness of 60-80 mils. The product's rapid curing properties allowed the air handling units to be quickly returned to service.
