Landscape & Water Features

Featuring Polyshield HT™

Private Ranch
Water Features & Ponds

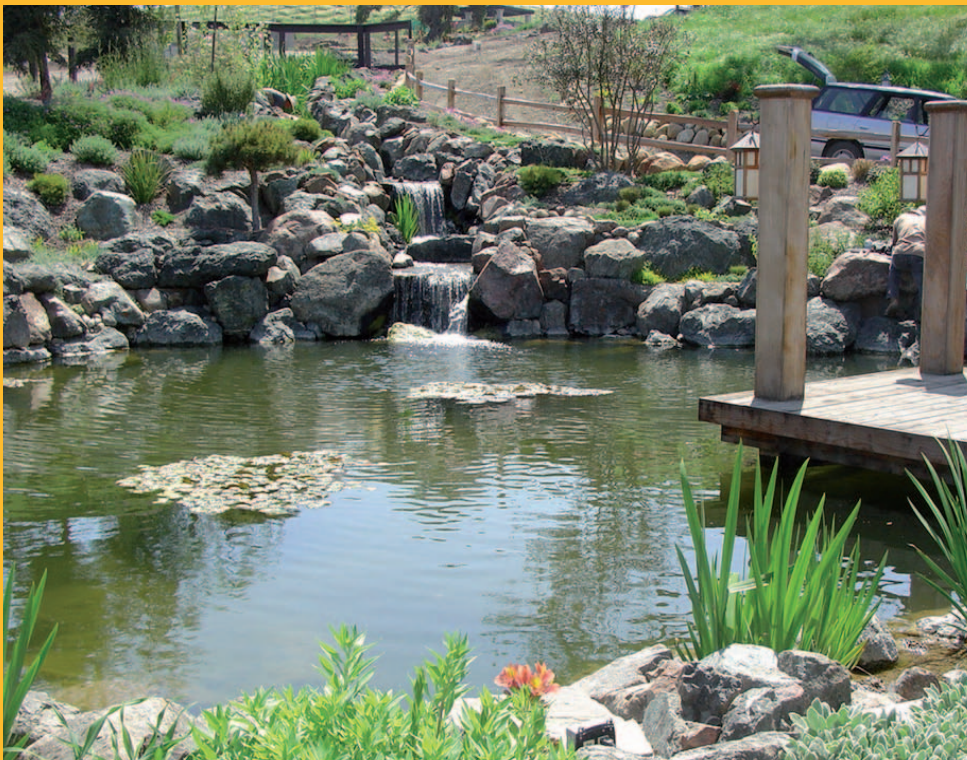
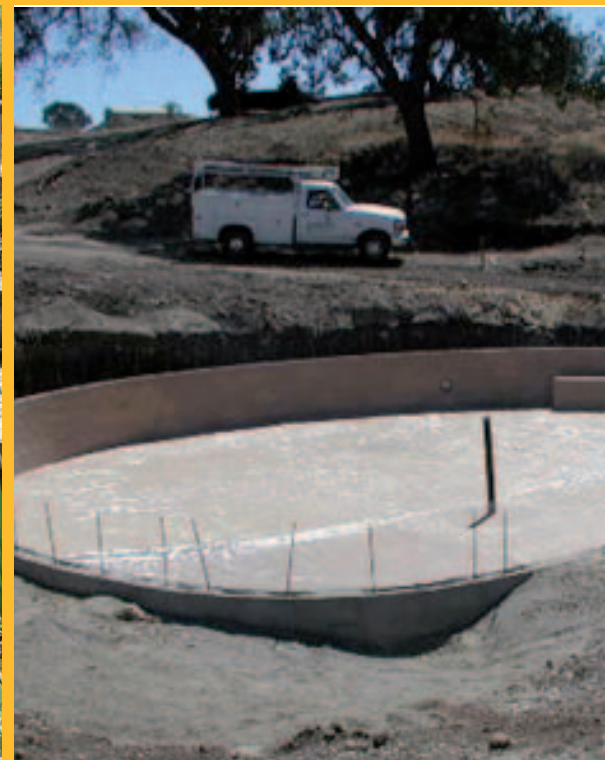
The contractor lined the pond basin with Amoco 1198 geo-textile fabric. Sand colored Polyshield HT™ polyurea was spray applied on top of the geo-textile fabric at 130 mils (basin) and 80 mils (perimeter walls). The coating was successfully tested for water leaks. Placement of heavy boulders did not damage the liner.
