Concrete Waterproofing & Abrasion Resistance

Featuring Polyshield HT™

Project:
Condominium Parking Garage

Coating System:
Polyshield HT™ - Slow
100 mils with non-slip aggregate

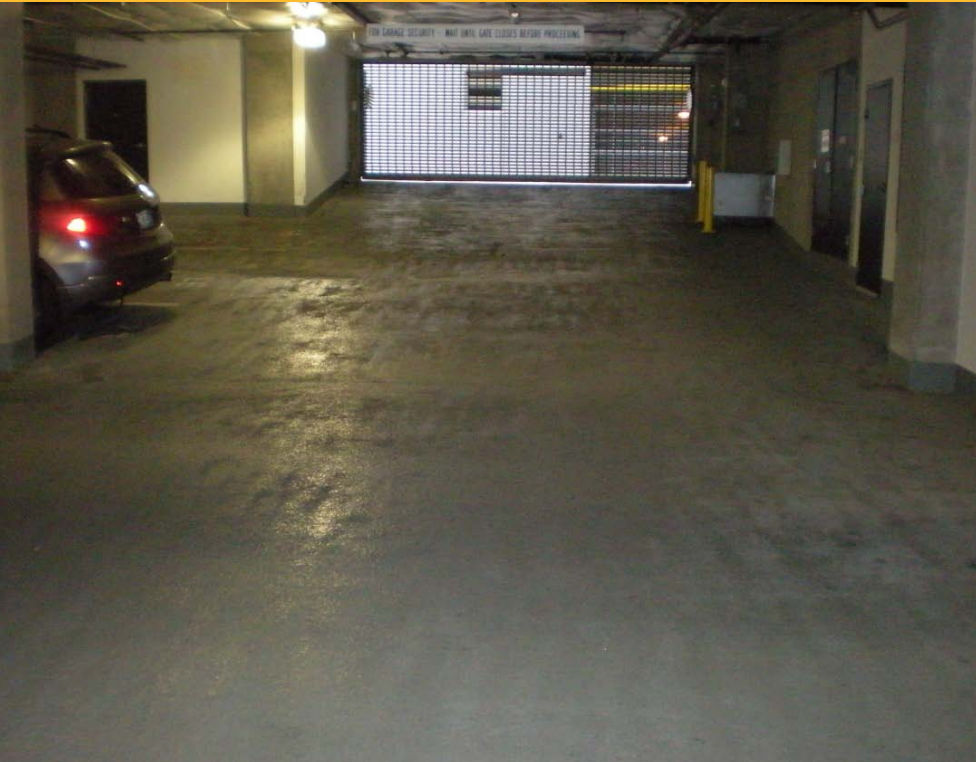
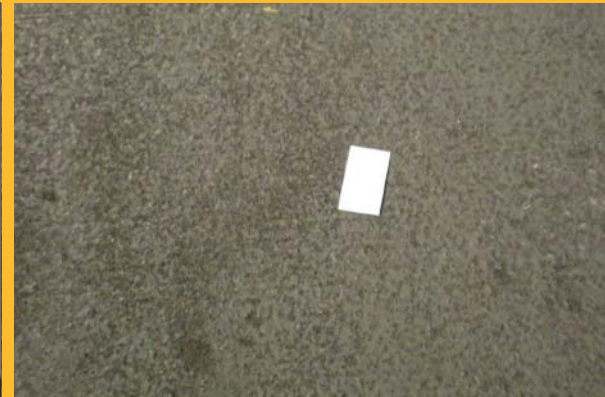
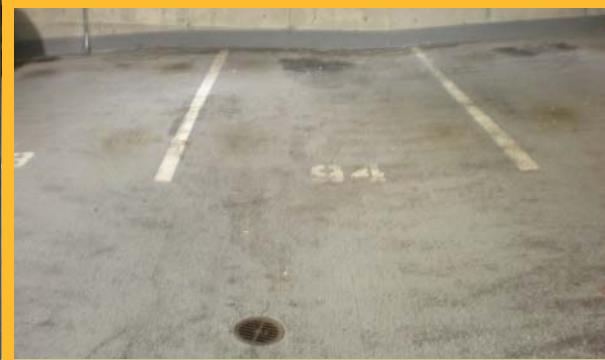
The project owner was delighted with the outcome and quick turn-around. New condo owners were able to move in on schedule. The parking garage was reinspected six years later (see below pictures). The polyurea is still performing well after years of high-volume vehicle traffic and weather cycles.

CDI Coatings, Inc. was awarded the contract. CDI and SPI recommended Polyshield HT™-Slow polyurea because of the product's waterproof, abrasion resistance, and rapid curing properties. The concrete surface was first sweep-blasted and cleaned.

Polyprime-100™ primer was applied to finish surface prep. A 40 mil base coat of SPI's Polyshield HT™-Slow polyurea was applied. Next, another 50 mils of Polyshield HT™-Slow was added with an aluminum oxide aggregate broadcast into the coating. Finally, the applicator sprayed a 10-15 mil topcoat to lock in the aluminum oxide aggregate and provide a non-slip surface. Due to the diligence of the CDI applicator crew and the product's rapid curing time, the entire project was completed and returned to service within 48 hours.
