# Water Proofing

## Featuring Polyshield SS-100®

**Project:**  
Fountain of the Flags

**Location:**  
Fairbanks, AK

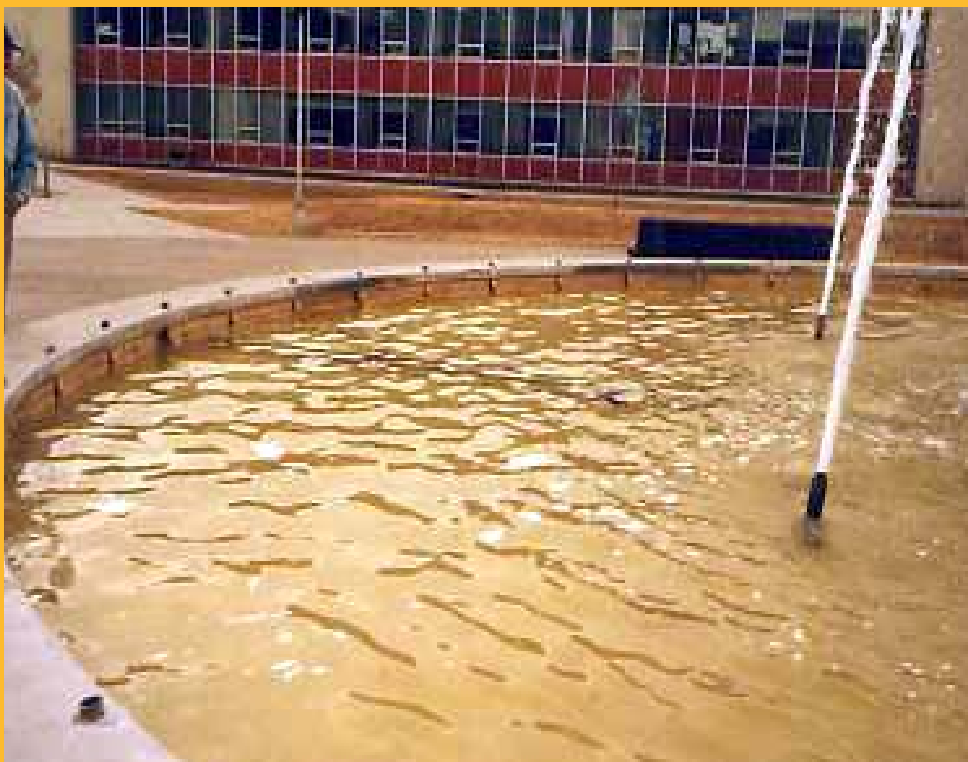
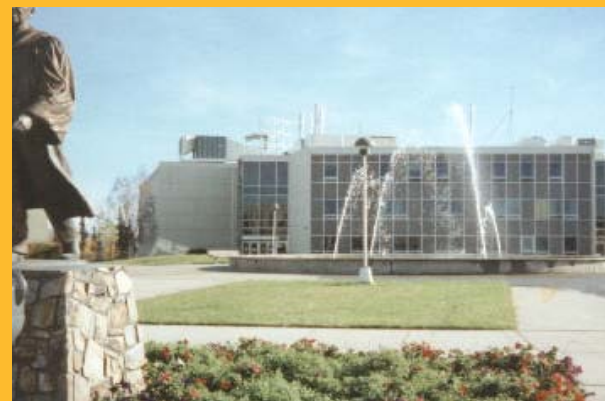
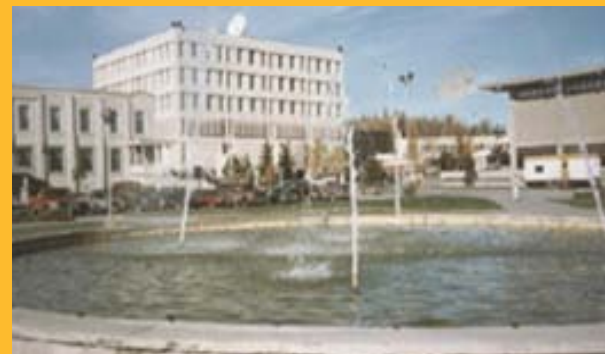
Microscopic cracks were found in the original epoxy coating of a 3,000 sq. ft. water feature, "The Fountain of the Flags" at the University of Alaska, Fairbanks. These cracks were causing leaks with a daily loss of thousands of gallons of water. The water was making its way into the plumbing corridor under the fountain, which potentially could be a serious and expensive problem if left untreated.

They chose Polyshield SS-100® because it forms a seamless, crack-bridging membrane that prevents water leakage. With high pigment added for color stability, Polyshield SS-100® was applied at 60 mils. The polyurea protective coating created a watertight seal.

University officials were relieved to have a reliable waterproof coating in place to protect the water feature's concrete surface. In a follow up inspection (summer 1996) the coating was performing well, with no loss of water and no discoloration.
