# Extending Service Life of Concrete

## Featuring Polyshield SS-100®

Lewis Street Underpass Spall Repair

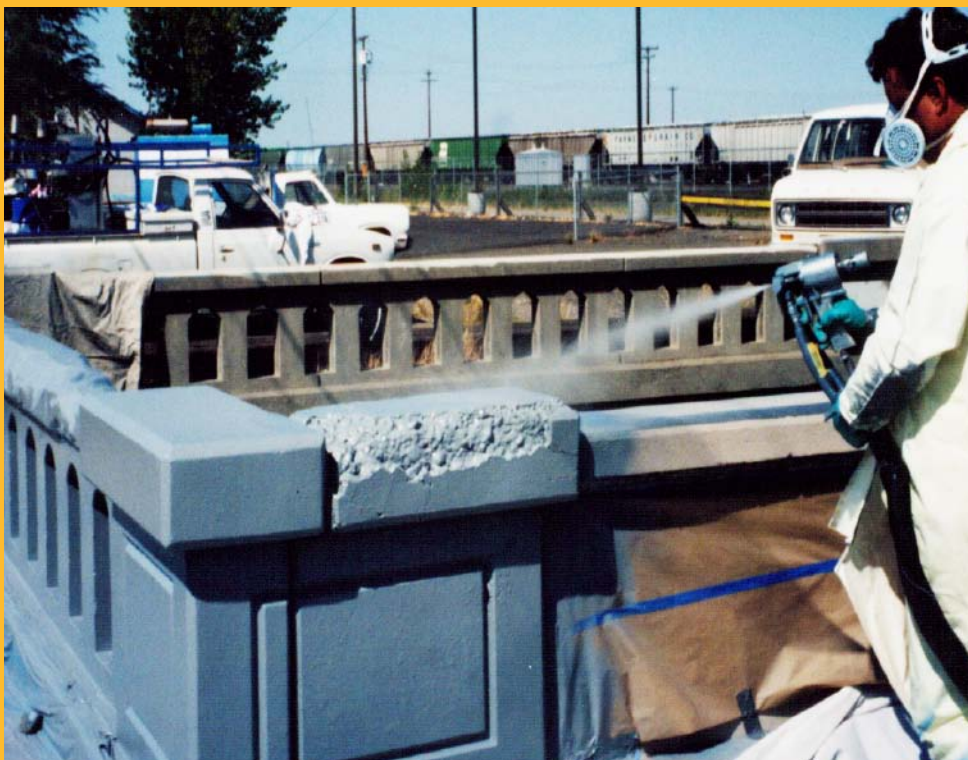
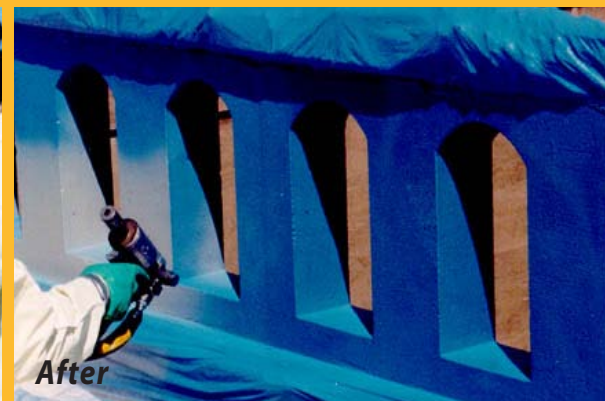
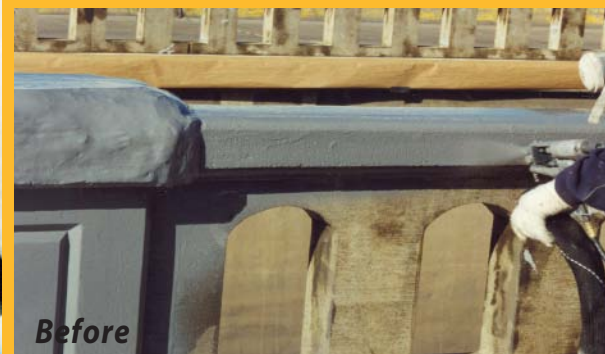
The Lewis Street Underpass was built in the 1930's with a low grade concrete. The concrete railing was spalling and falling on the cars below. Until the underpass could be replaced in the next 5-10 years, the city of Pasco needed an economical way to prevent the spalling. Because the underpass has a high volume of pedestrian and automobile traffic, a major concern for the project engineer was a quick turnaround time.

was first hydro-blasted at 10,000 psi, then primed with three coats of Devoe 167 penetrating sealer. Next, a quick-set grout was used to fill the larger gaps on the rail cap. Another coat of penetrating sealer sealed the grout. The rail caps were then coated with 120 mils of Polyshield SS-100® and the vertical rail surfaces were coated with 60 mils.
